Manhole Inspection Summary

Manhole # S150__045MH

Location Address: **2701 east lynne av**

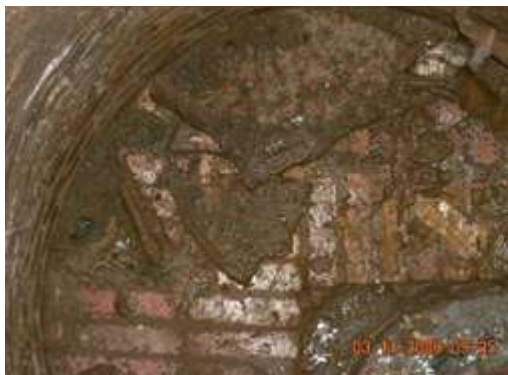
Defect 4

Condition: ☐ Sound ☐ Cracked ☐ Root Intrusion ☐ Deteriorated ☐ Leaks ☒ **Debris**

debris on bench and channel

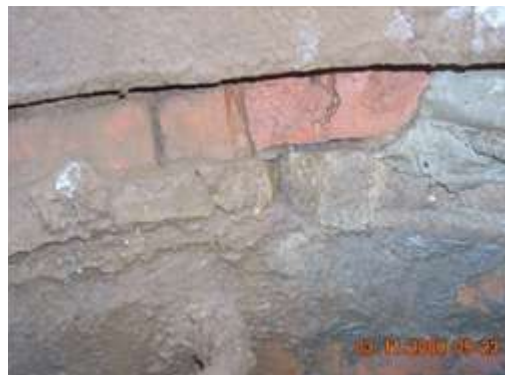
Defect 5

Condition: ☐ Sound ☒ **Cracked** ☐ Root Intrusion ☒ **Loose Brick** ☐ Deteriorated

cracked chimney bricks

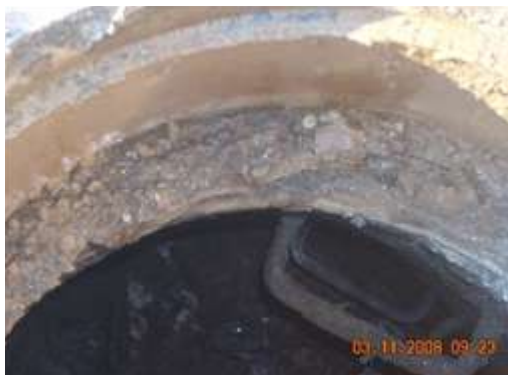
Defect 3

Offset: **2** (in.)

frame offset

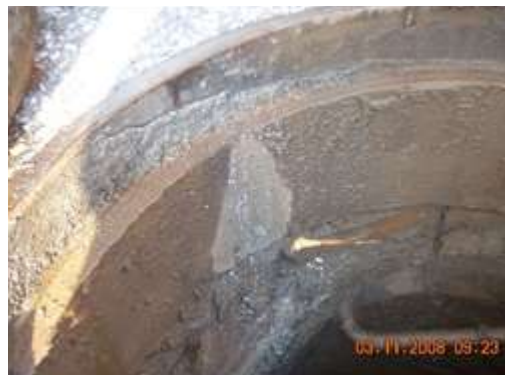
Misc

inflow evidence

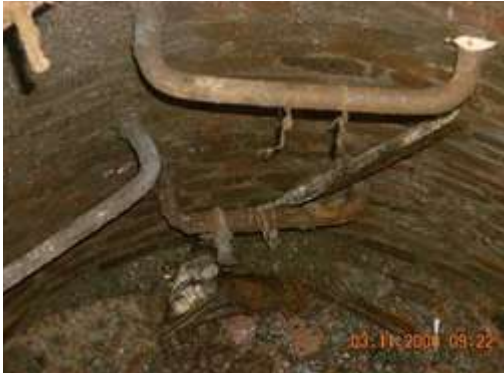
Defect 1

☒ **Evidence Of Surcharge** Depth: **4** (ft.) ☐ Active Surcharge Present

surcharge evidence on steps

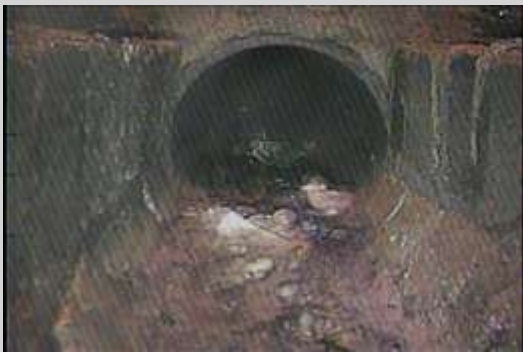
12 O'Clock Outflow

Pipe Height: **8.4** (in.) Rod and Bar (Angled)
Pipe Material: **Clay** ☐ Pipe Lined
Invert Depth: **9.33** (ft.) Flow Characteristics: **Slow**
Deposits: ☐ None ☐ Mud ☐ Sludge ☒ **Debris** ☐ Grease
Silt Depth: **1** (in.) Deposits Extent: **Light**
Infiltration: **None** Pipe Seal Cond: **Sound**
